Manhole Inspection Summary

Manhole # S15A1_002MH

Insp Date: **6/19/08 2:45 PM**

Location Address: **1401 st marks av**

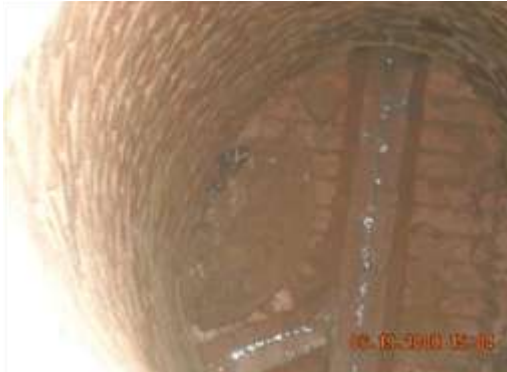
Defect 2

Condition: ☐ Sound ☐ Cracked ☐ Root Intrusion ☐ Deteriorated ☐ Leaks ☒ Debris

debris on bench; half a manhole lid

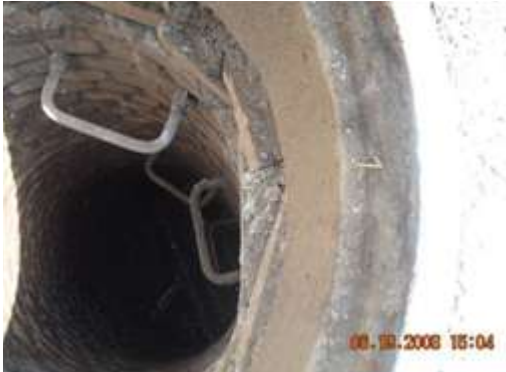
Defect 1

Frame Offset: **1** (in.) Condition: ☒ Sound ☐ Cracked ☐ Leaks

frame offset

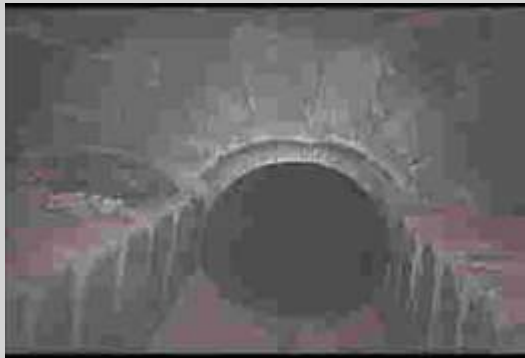
12 O'Clock Outflow

8 in. Circular Gravity Sewer
Pipe Out @ 12 O'Clock

Pipe Height: **8.4** (in.) Rod and Bar (Angled)
Pipe Material: **Clay** ☐ Pipe Lined
Invert Depth: **13.13** (ft.) Flow Characteristics: **Slow**
Deposits: ☒ None ☐ Mud ☐ Sludge ☐ Debris ☐ Grease
Silt Depth: **0** (in.) Deposits Extent:
Infiltration: **None** Pipe Seal Cond: **Sound**

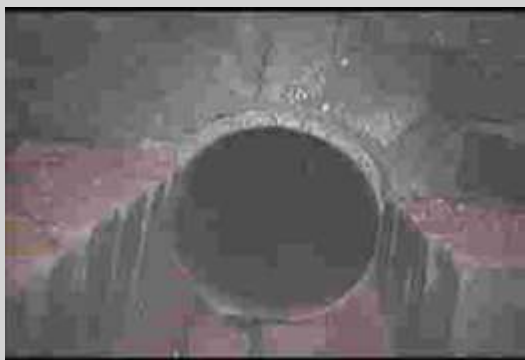
6 O'Clock Inflow

8 in. Circular Gravity Sewer
Pipe In @ 6 O'Clock

Pipe Height: **8.4** (in.) Rod and Bar (Angled)
Pipe Material: **Clay** ☐ Pipe Lined
Invert Depth: **12.91** (ft.) Flow Characteristics: **Slow**
Deposits: ☒ None ☐ Mud ☐ Sludge ☐ Debris ☐ Grease
Silt Depth: **0** (in.) Deposits Extent:
Infiltration: **None** Pipe Seal Cond: **Sound**

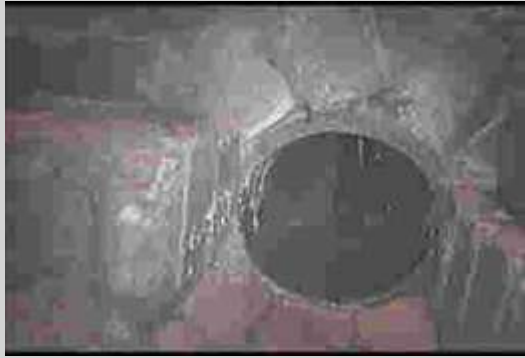
8 O'Clock Inflow

6 in. Circular Gravity Sewer
Pipe In @ 8 O'Clock

Pipe Height: **6** (in.) Rod and Bar (Angled)

Pipe Material: **Clay** ☐ Pipe Lined

Invert Depth: **12.82** (ft.) Flow Characteristics: **Slow**

Deposits: ☒ None ☐ Mud ☐ Sludge ☐ Debris ☐ Grease

Infiltration: **None**

Pipe Seal Cond: **Sound**
